CONSERVATION STORIES

The conservation of Jackson Pollock's *Mural*, beginning in 2012 by the Getty Research Institute, Los Angeles, yielded new insights into its materials and painting technique. This recent conservation can be compared with the historic treatment of Robert Motherwell's *Elegy to the Spanish Republic, No. 126*.

Conserving *Mural*

Preparing *Elegy to the Spanish Republic, No. 126*

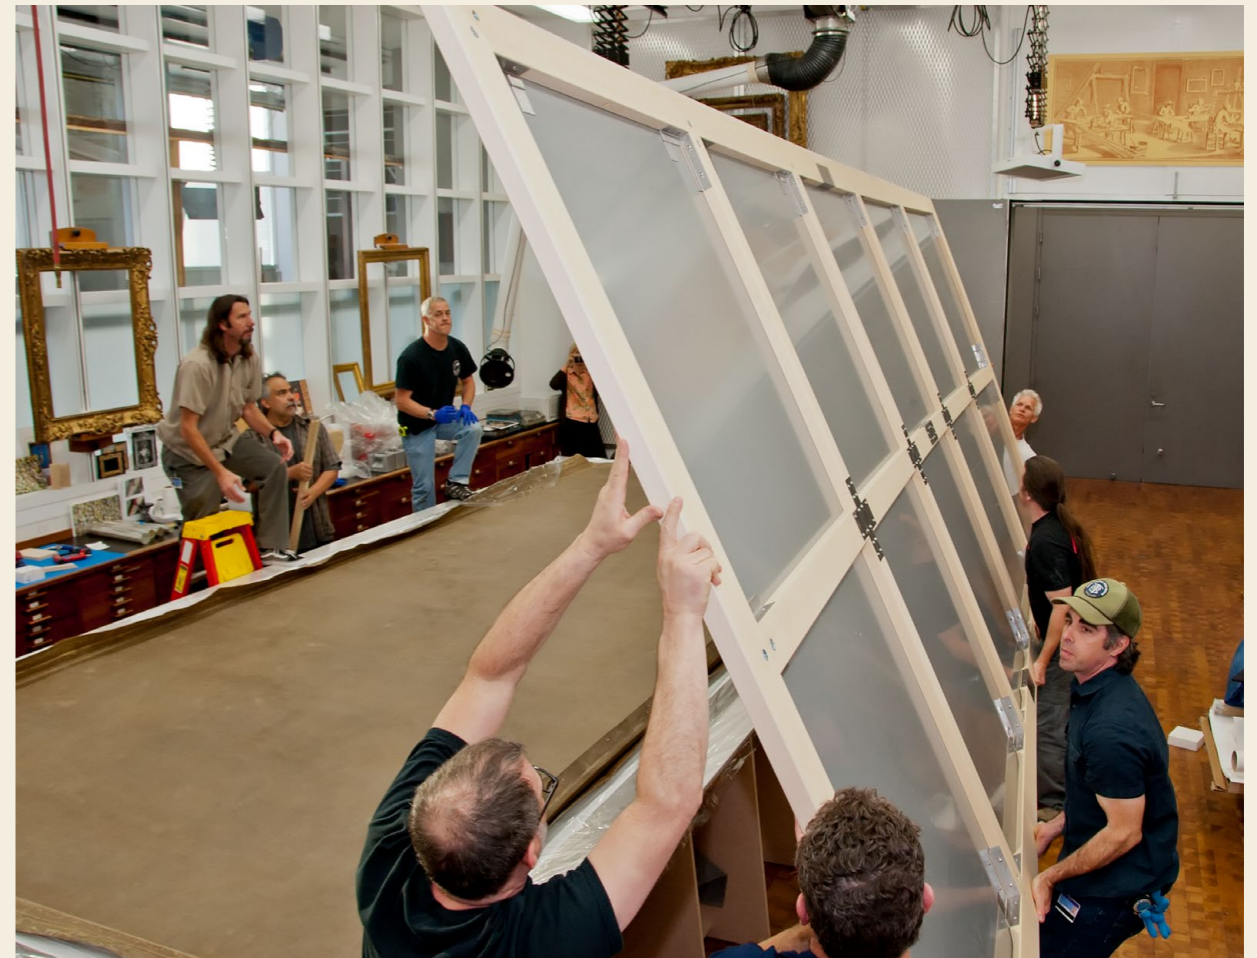
From the very beginning, Pollock's stretcher was likely not sturdy enough to properly support the heavy canvas. Early photographs suggest that the upper canvas may have begun to sag even as it was painted.

The canvas distortion grew worse with time. In 1973, the painting was re-stretched onto a new support.

However, this treatment resulted in areas of the original tacking margins becoming visible at places on the picture plane.

Many people and much planning were necessary to secure such a large painting onto a new stretcher. Image courtesy of the Getty Research Institute, Los Angeles.

When *Mural* arrived at the Getty, the stretcher was deemed inadequate. During the 2012 treatment, the painting was mounted onto a stretcher designed to follow the contours of the original painted surface. While the painting is no longer perfectly rectangular, the subtle contour allows *Mural* to be seen as closely as possible to its original presentation.

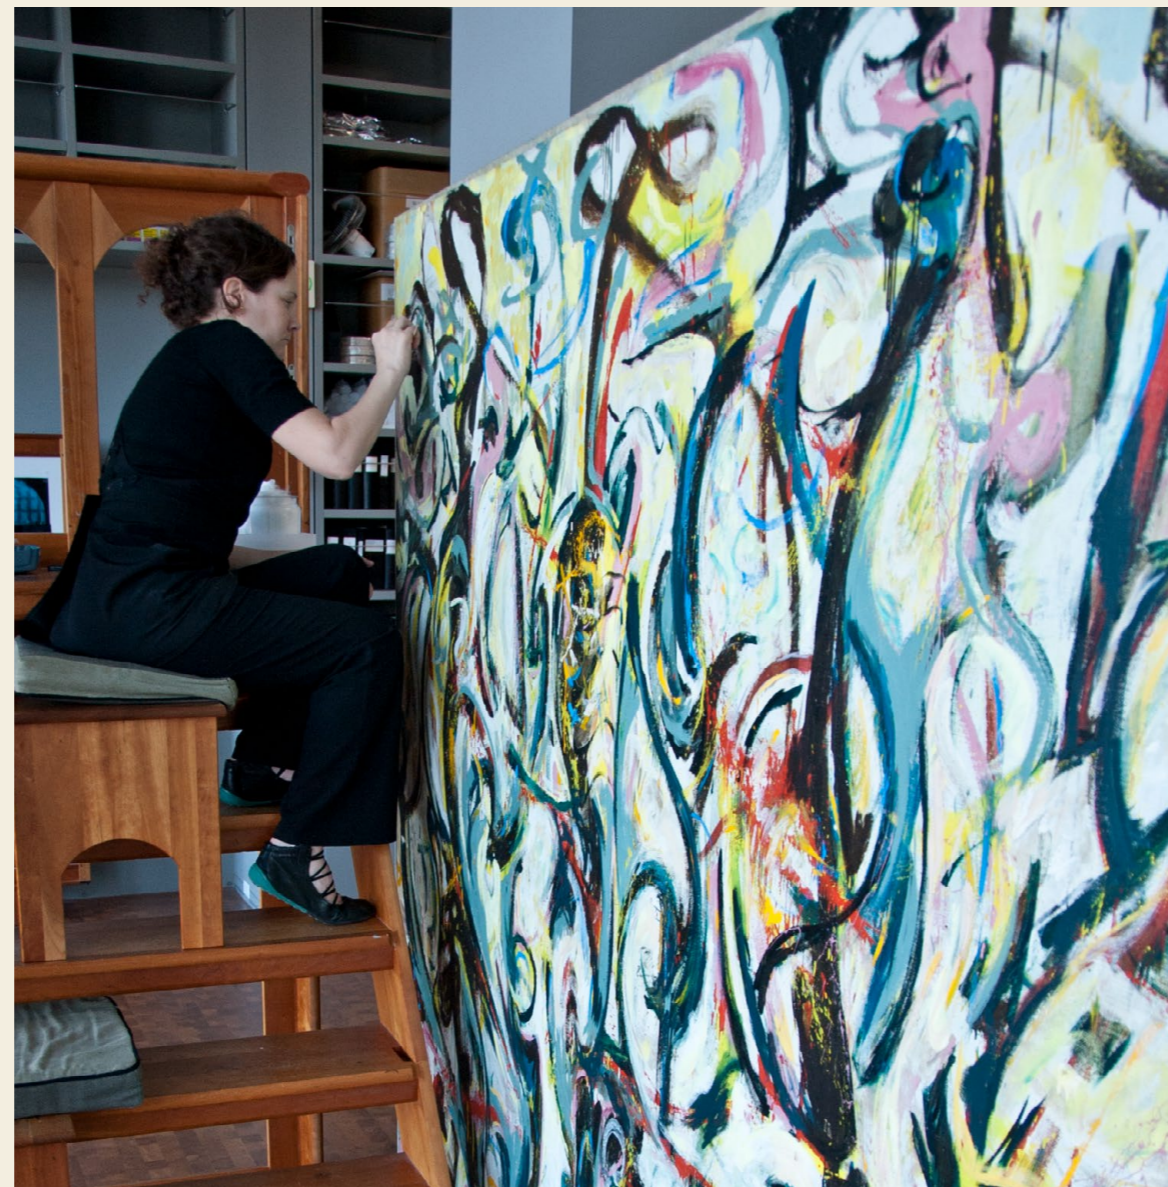
Conservator removing dirt and grime from the surface of *Mural*.
Image courtesy of the Getty Research Institute, Los Angeles.

The glossy varnish applied to *Mural* as part of the conservation treatment in 1973 was intended to protect its surface but with time it had become somewhat cloudy. Combined with accumulated grime, it dulled the original surface qualities and vibrant colors of the painting. Furthermore, the uniformly reflective surface of the varnish prevented viewers from observing the entire composition from one vantage point.

During the 2012 treatment, the grime and varnish were carefully removed with small cotton swabs and mild, water-based solutions. As a result, the painting's appearance is now closer to Pollock's original intention, with a varied and richly painted surface, both glossy and matte.

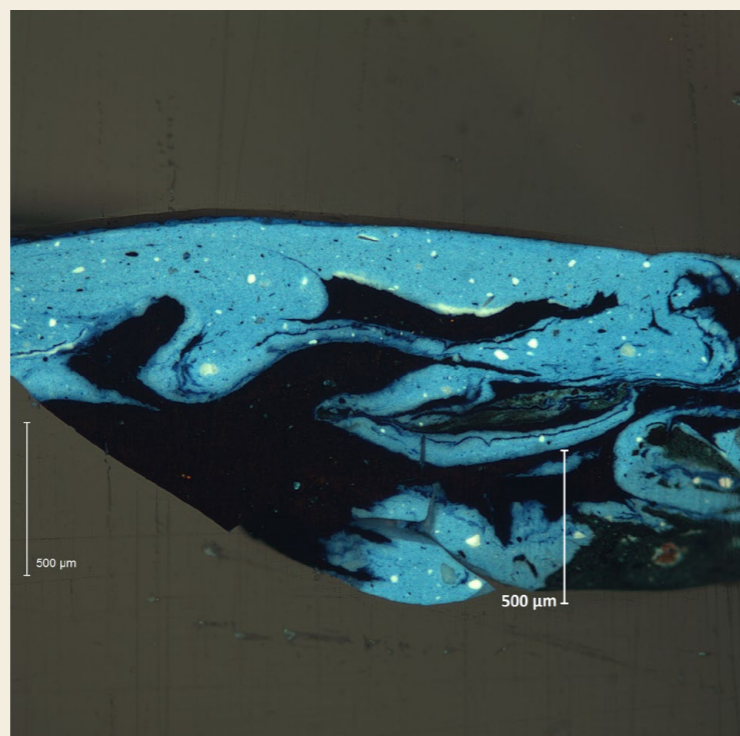
The physical evidence tends to support Pollock’s version of the story: oil paint is slow to dry, and much of the paint application on *Mural* can be described as wet-over-dry (wet paint is applied on top of paint that has already dried). Cross-sections of paint samples show clearly defined paint layers (see top image).

Top: Sample taken and prepared as a cross section. Every paint layer is distinct, showing that the previous ones were dry.

Bottom: Sample taken and prepared as a cross section. An example of Pollock applying paint over still-wet paint. The two layers blend in a revealing swirl.
