CONSERVATION STORIES

The conservation of Jackson Pollock's *Mural*, beginning in 2012 by the Getty Research Institute, Los Angeles, yielded new insights into its materials and painting technique. This recent conservation can be compared with the historic treatment of Robert Motherwell's *Elegy to the Spanish Republic, No. 126*.

Conserving *Mural*

Preparing *Elegy to the Spanish Republic, No. 126*

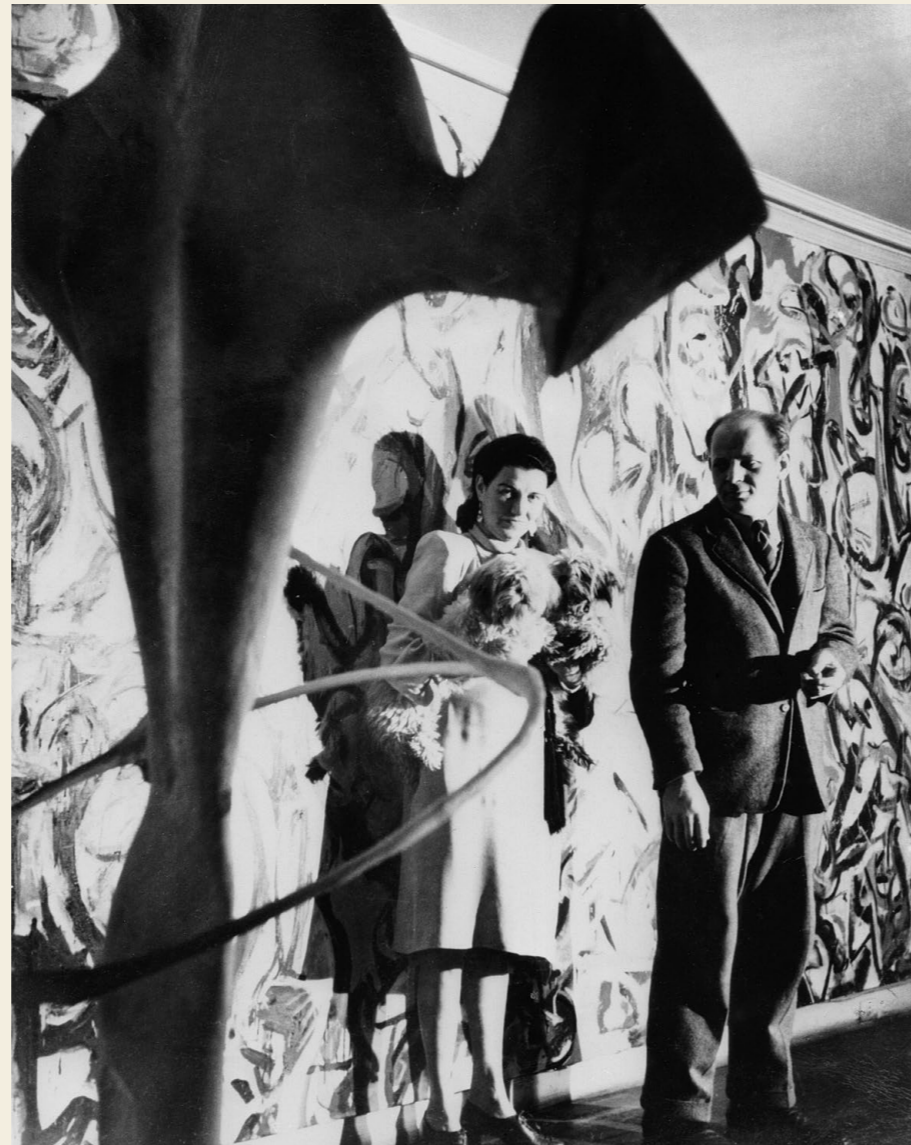
Mural's early itinerant history took a toll on its condition. The paint began to flake, and the weak original stretcher caused the canvas to develop a pronounced sag. By 1973 its structural condition was in need of attention, and a conservation treatment was carried out in Iowa to stabilize it. This included lining the painting (attaching a secondary canvas to the reverse of the painting using adhesive), replacing the original stretcher with a sturdier one, and varnishing the painting.

By 2012, grime had accumulated on the surface, and the varnish had aged poorly. The 1973 lining stabilized the flaking paint, but the weight of the lining materials worsened the canvas distortion. Additionally, the replacement stretcher was insufficient to support the extra weight of the double canvas. The more rectangular shape drew unpainted canvas, originally on the sides, to the front. The recent treatment of *Mural* at the Getty Research Institute, Los Angeles, removed the grime and varnish, replaced the stretcher, and attempted to reestablish the painting's original edges.

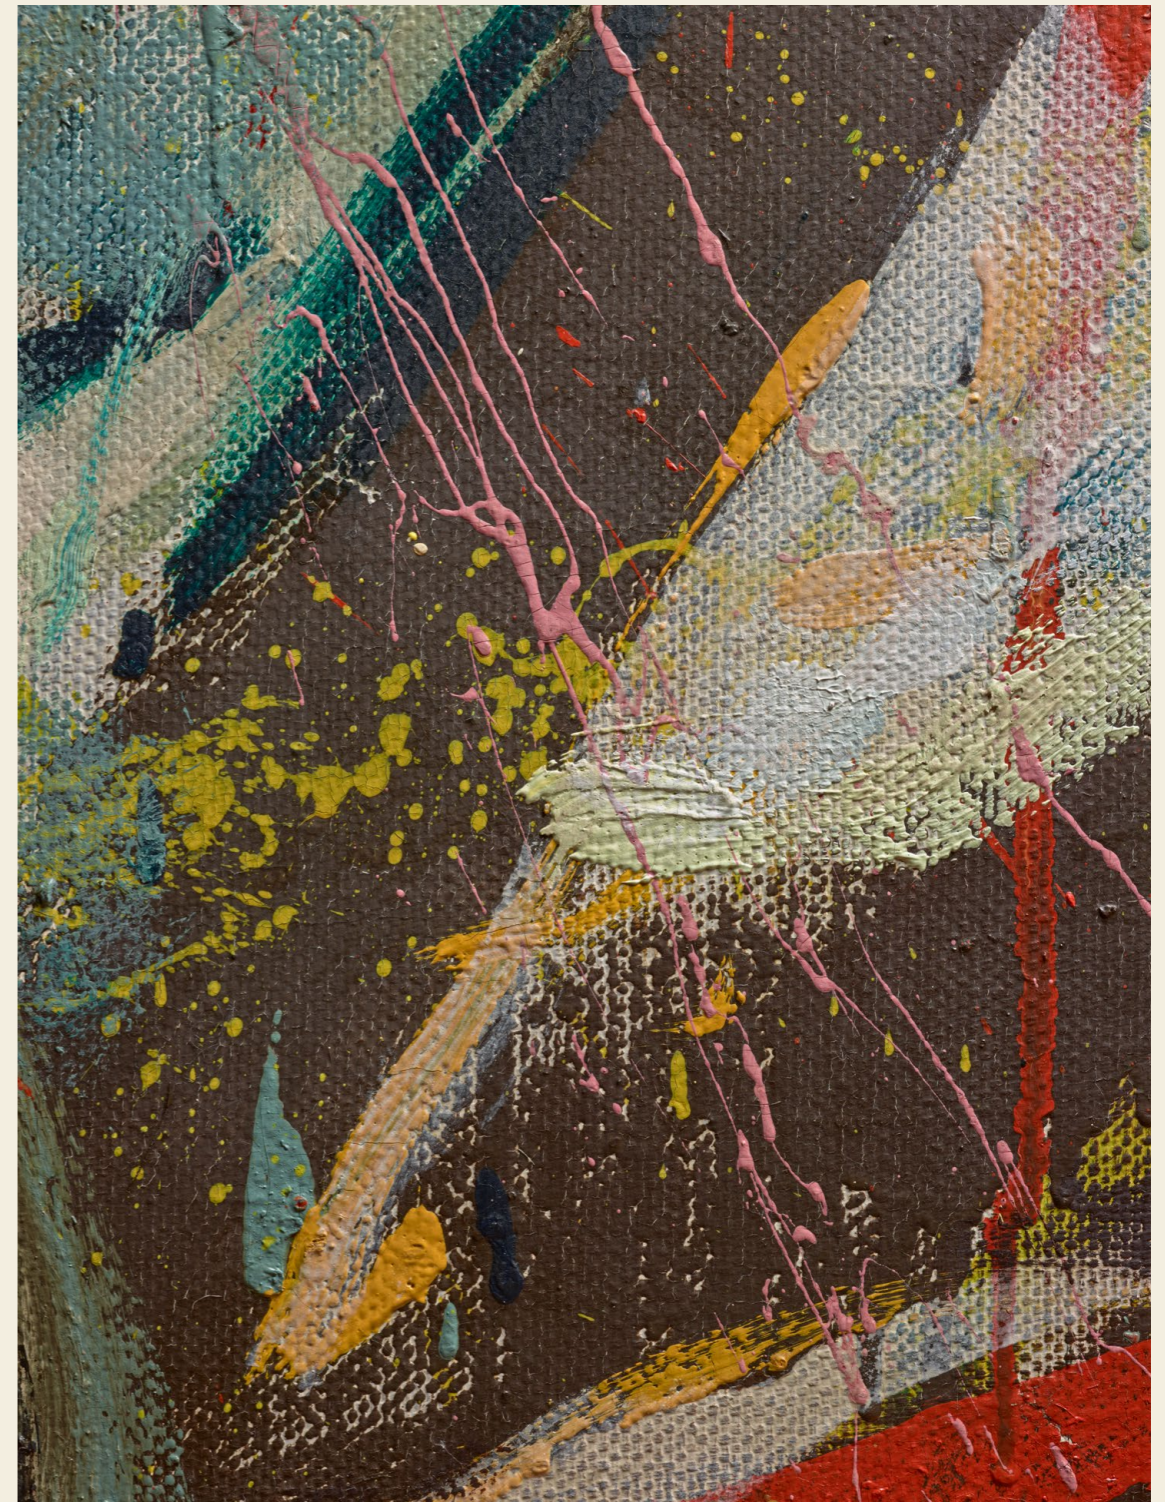
Some of the paint splatters—the pink stringy color in particular—resemble Pollock’s later “drip,” or “action,” paintings, where the canvas was placed flat on the studio floor. In this case, conservators were able to reproduce the drip effects on a vertical test canvas, confirming that Pollock painted *Mural* with the canvas positioned vertically. The combination of quickly applied brushwork and spontaneously thrown paint is evident across much of the painting.

Detail of *Mural* showing skeins of delicate pink paint that foreshadow Pollock’s later drip technique. Image courtesy of the Getty Research Institute, Los Angeles.

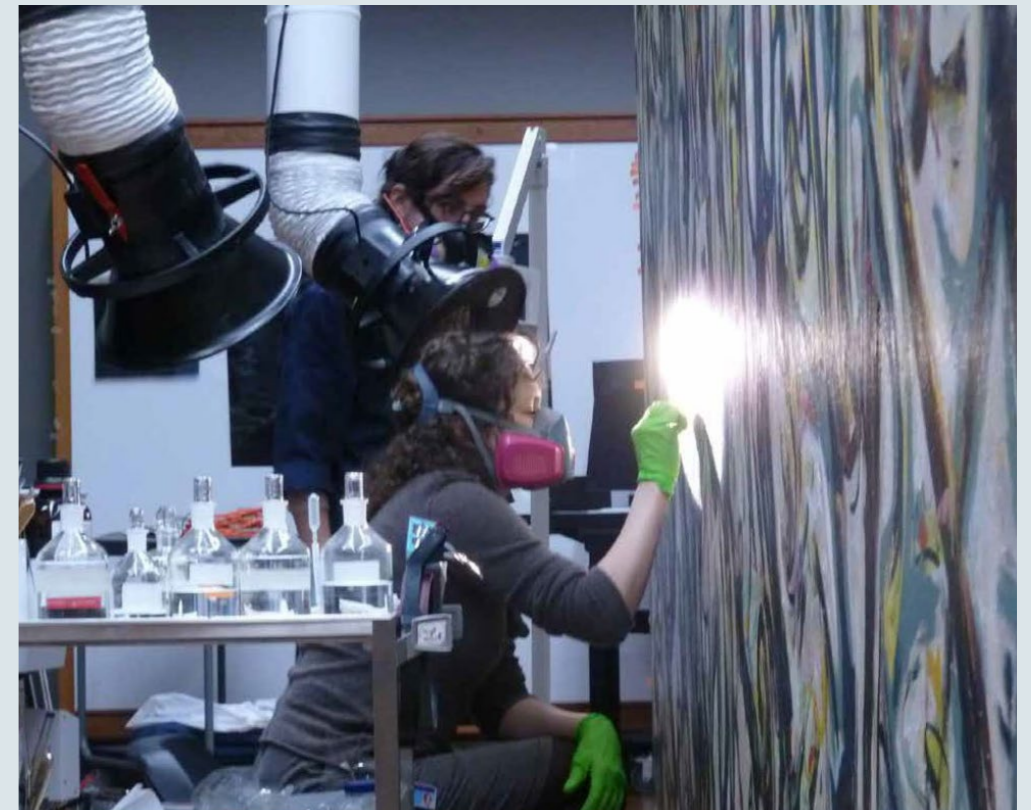
Getty Institute conservators cleaning *Mural* using state-of-the-art techniques and materials. Image courtesy of the Getty Research Institute, Los Angeles.

During the 2012 treatment, the grime and varnish were carefully removed with small cotton swabs and mild, water-based solutions. As a result, the painting's appearance is now closer to Pollock's original intention, with a varied and richly painted surface, both glossy and matte.
